BUREAU OF SHIPS GROUP TECHNICAL INSPECTION REPORT

U.S.S. ARDC 13

TEST ABLE [redacted] 8

⑥ OPERATION CROSSROADS. Director
Defense Atomic Support Agency
Washington, D. C. 20301

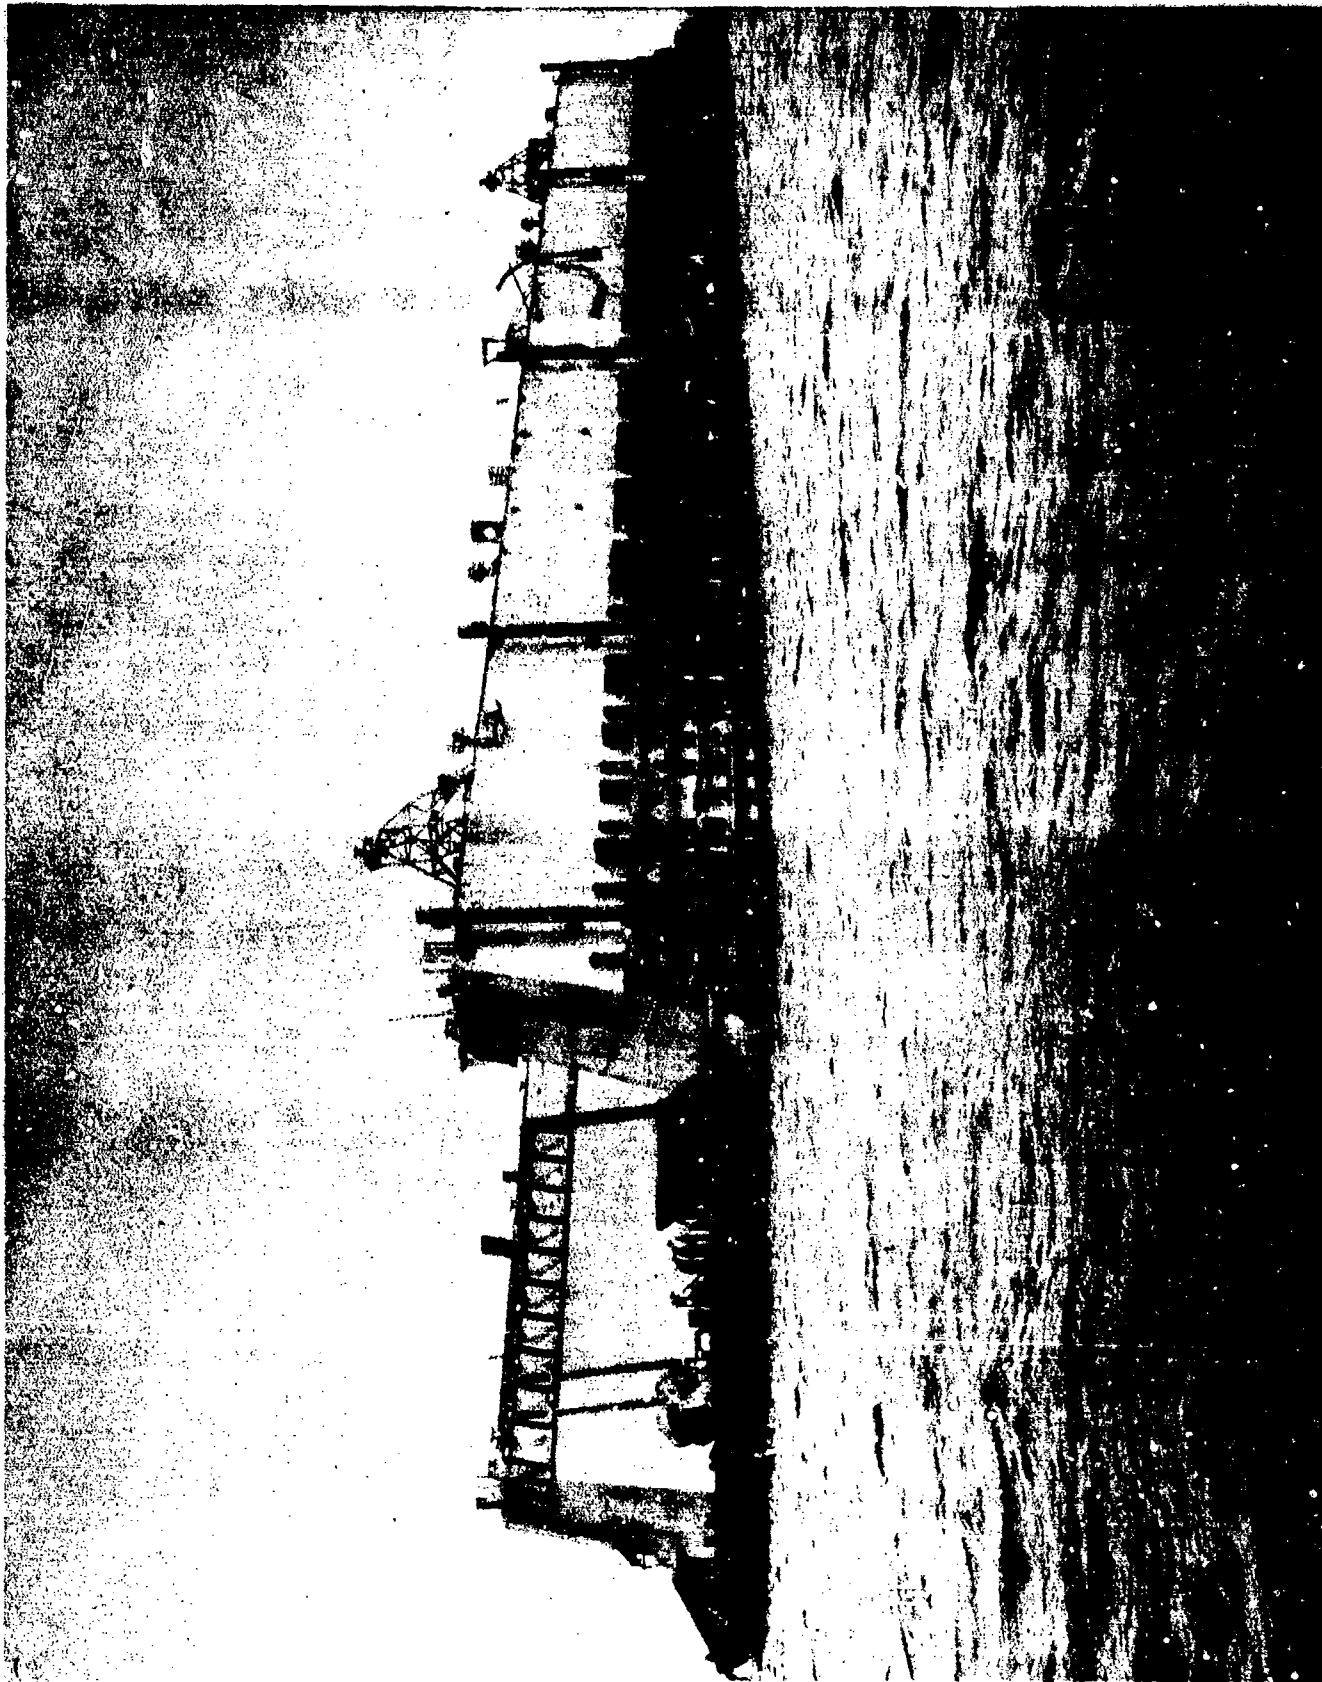
AA-CR-227-50-133. View from off port bow after Test A.

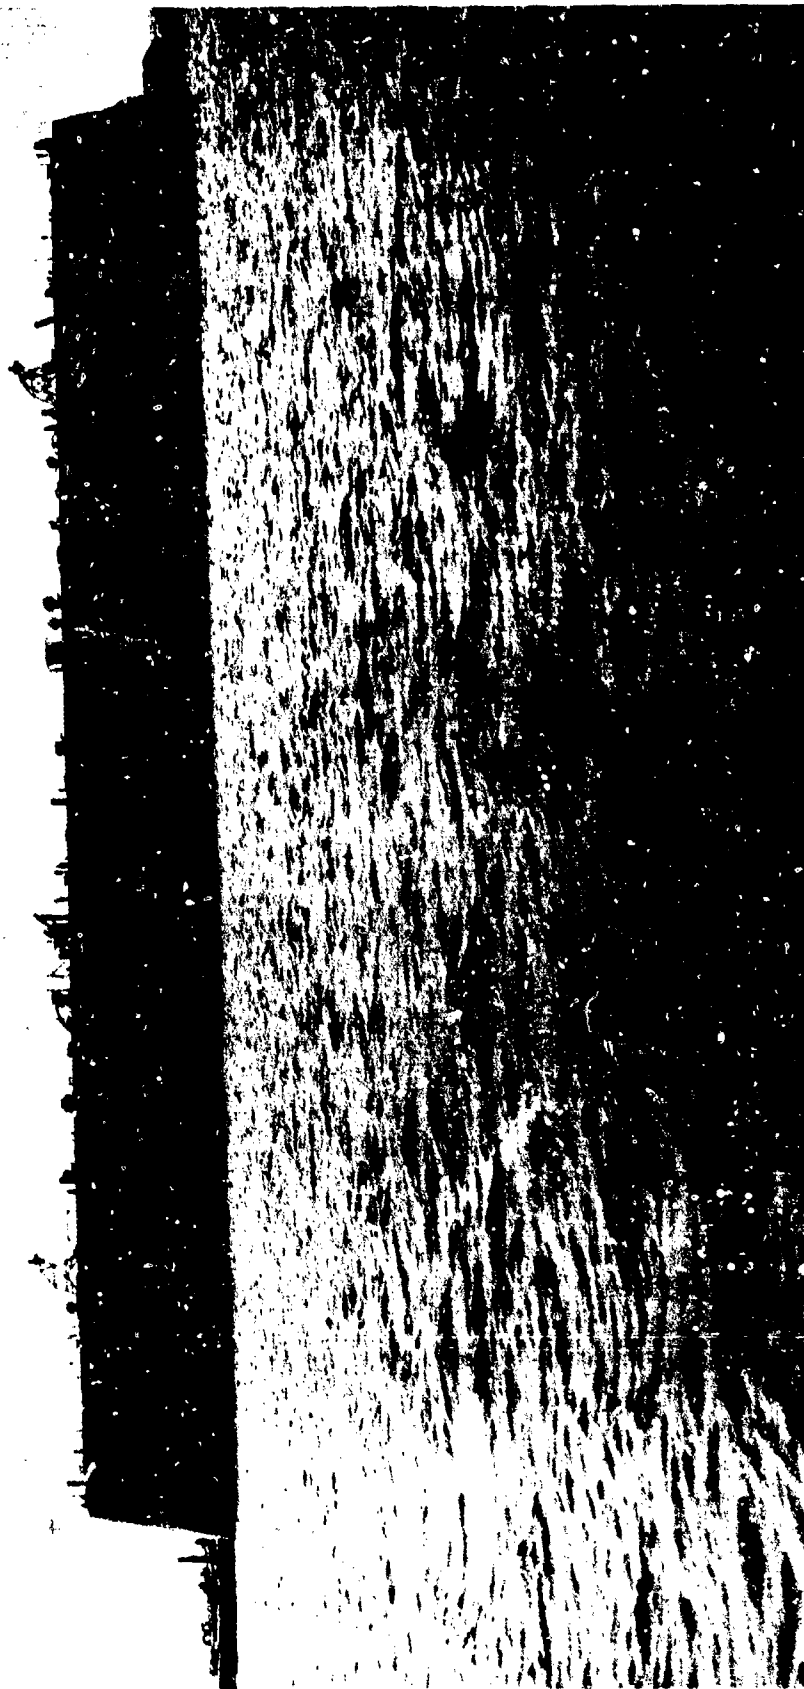
AA-CR-227-50-130. View from off starboard beam after Test A.

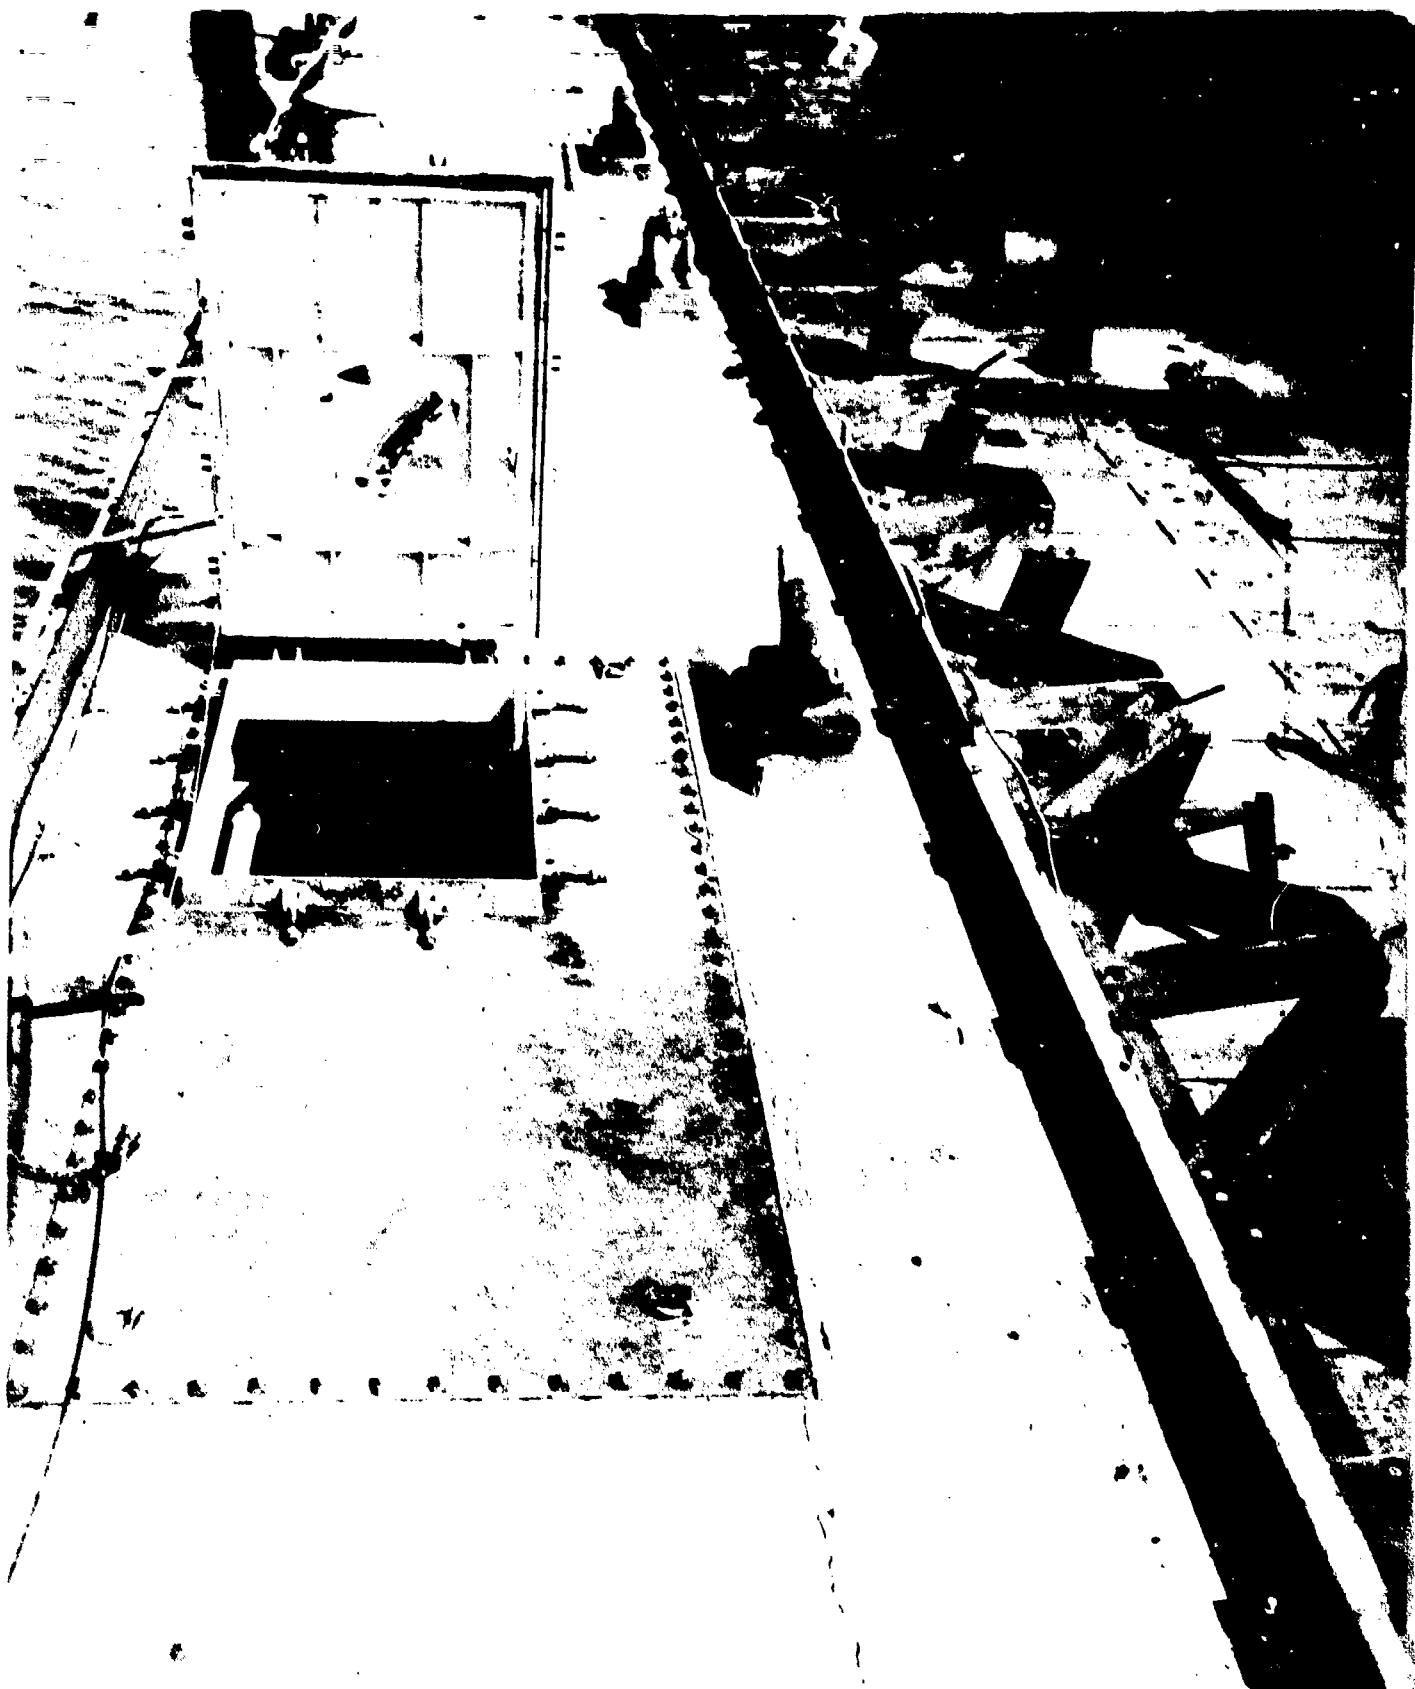
AA-CR-82-1914-4. View looking forward, port side, showing crack in "A" deck.
